Research publication 78

PREVENTION OF FROST HEAVE IN MANHOLES

Ministry
of the
Environment

A. Cohen
Applied Sciences Section
Pollution Control Branch

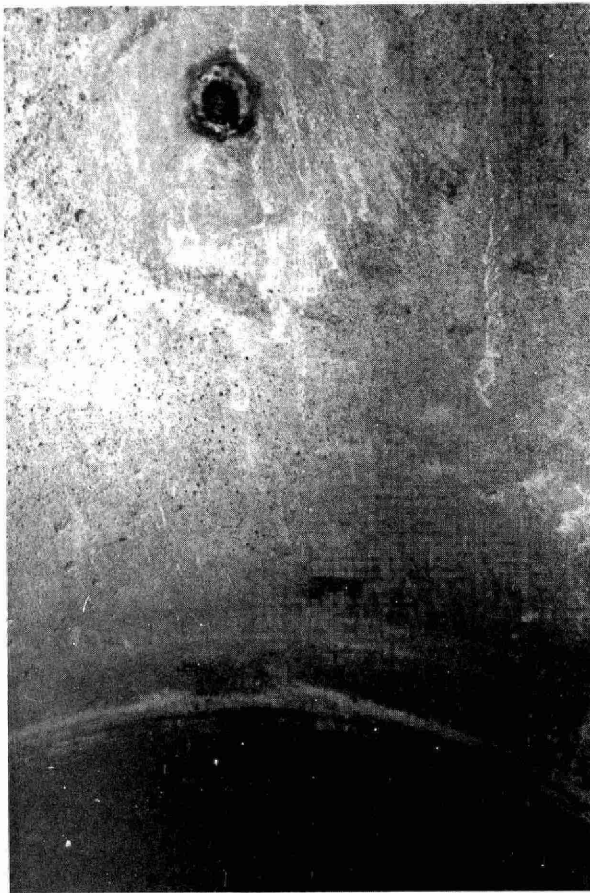
FIG 8

A - DIAGONAL STRAP : LEAK
B - VERTICAL STRAP : NO LEAK
C - BETWEEN STRAPS
THESSALON

Inspection after two winters showed that no manhole heaved in cases in which the two strap bolts were installed one above the other. However, in those shallow manholes under bare roads where the strap was installed in an inclined manner or diagonally along the outside wall, separation occurred. In one case (Fig. 8) where on one side of the manhole the strap was vertical and the other diagonal, there was no separation on the vertical strap side but there was on the side of the **diagonal strap**.
